Manhole Inspection Summary

Manhole # S43U__001MH

Insp Date: **3/5/08 1:18 PM**

Location Address: **1300 beason st.**

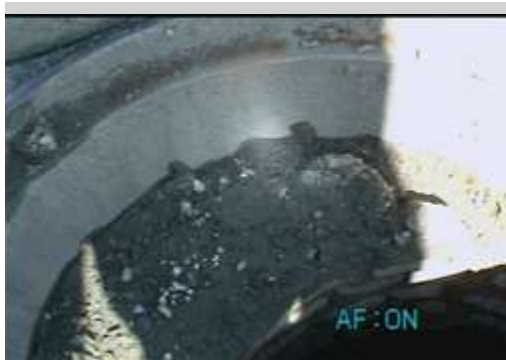
Defect 1

Frame Offset: **6** (in.) Condition: ☒ Sound ☐ Cracked ☐ Leaks

off set defect

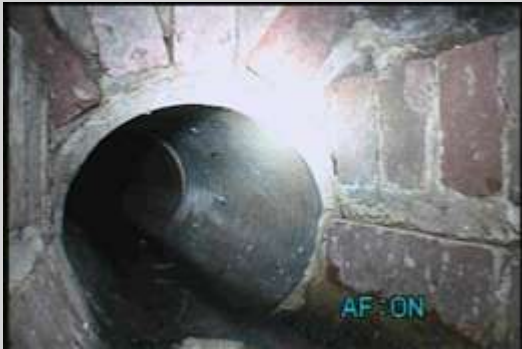
12 O'Clock Outflow

8 in. Circular Gravity Sewer
Pipe Out @ 12 O'Clock

Pipe Material: **Clay** ☐ Pipe Lined

Invert Depth: **8.70** (ft.) Flow Characteristics: **Slow**

Deposits: ☒ None ☐ Mud ☐ Sludge ☐ Debris ☐ Grease

Infiltration: **None** Pipe Seal Cond: **Unknown**

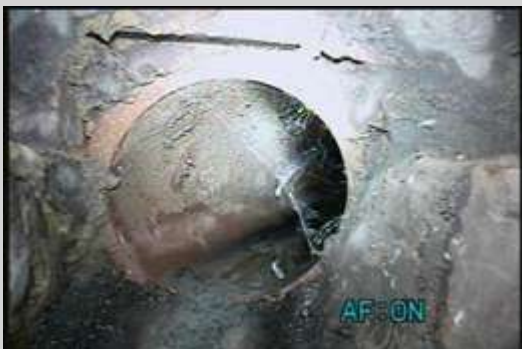
4 O'Clock Inflow

8 in. Circular Gravity Sewer
Pipe In @ 4 O'Clock

Pipe Material: **Clay** ☐ Pipe Lined

Invert Depth: **8.40** (ft.) Flow Characteristics: **Slow**

Deposits: ☒ None ☐ Mud ☐ Sludge ☐ Debris ☐ Grease

Infiltration: **None** Pipe Seal Cond: **Unknown**
